**PHASE I ENVIRONMENTAL ASSESSMENT VERIFICATION INSPECTION
REPORT, ORANGE COUNTY METAL PROCESSING, 1711 E. KIMBERLY
AVENUE, FULLERTON, CALIFORNIA 92634**

Phase I Environmental Assessment Checklist Verification Inspection Report

Facility Name: Orange County Metal Processing (OCMP)

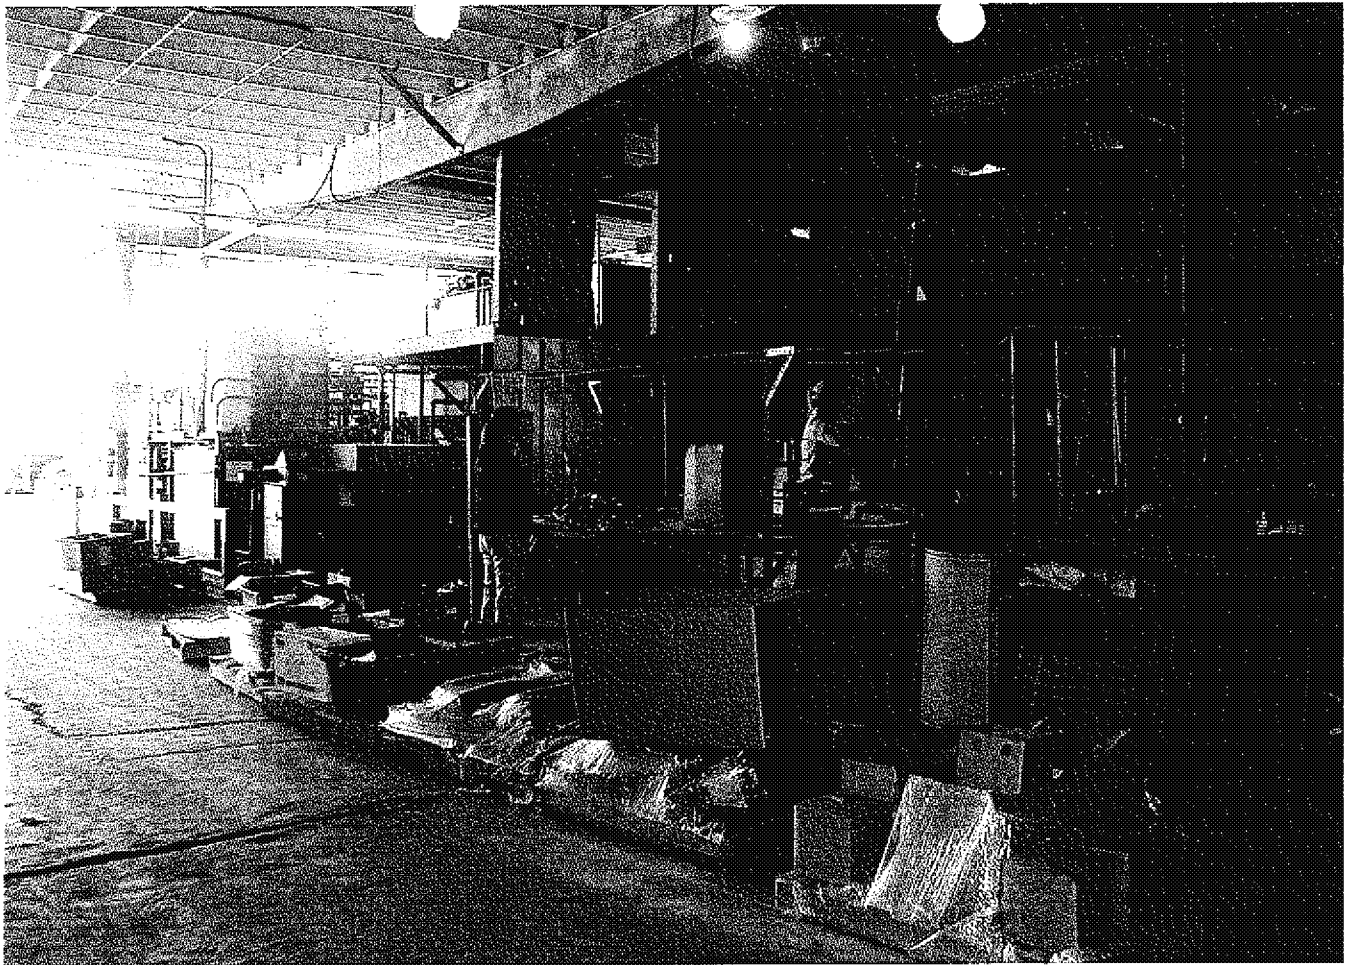
After our discussion, the owner led us to the ZPL in the adjacent building. The owner began to tell us what the ZPL was for and the type of chemicals used in the process. In between the drying rack and the ZPL tanks, the walk way was stained, had etch marks and areas of discoloration (Photo #13). Next, we went to the middle of the ZPL area room, where the ZPL, the drying rack and the Hazardous Wastewater Treatment System were located (Photo #11).

Products to have finish applied - 11
Wastewater Treatment System
Zinc Line

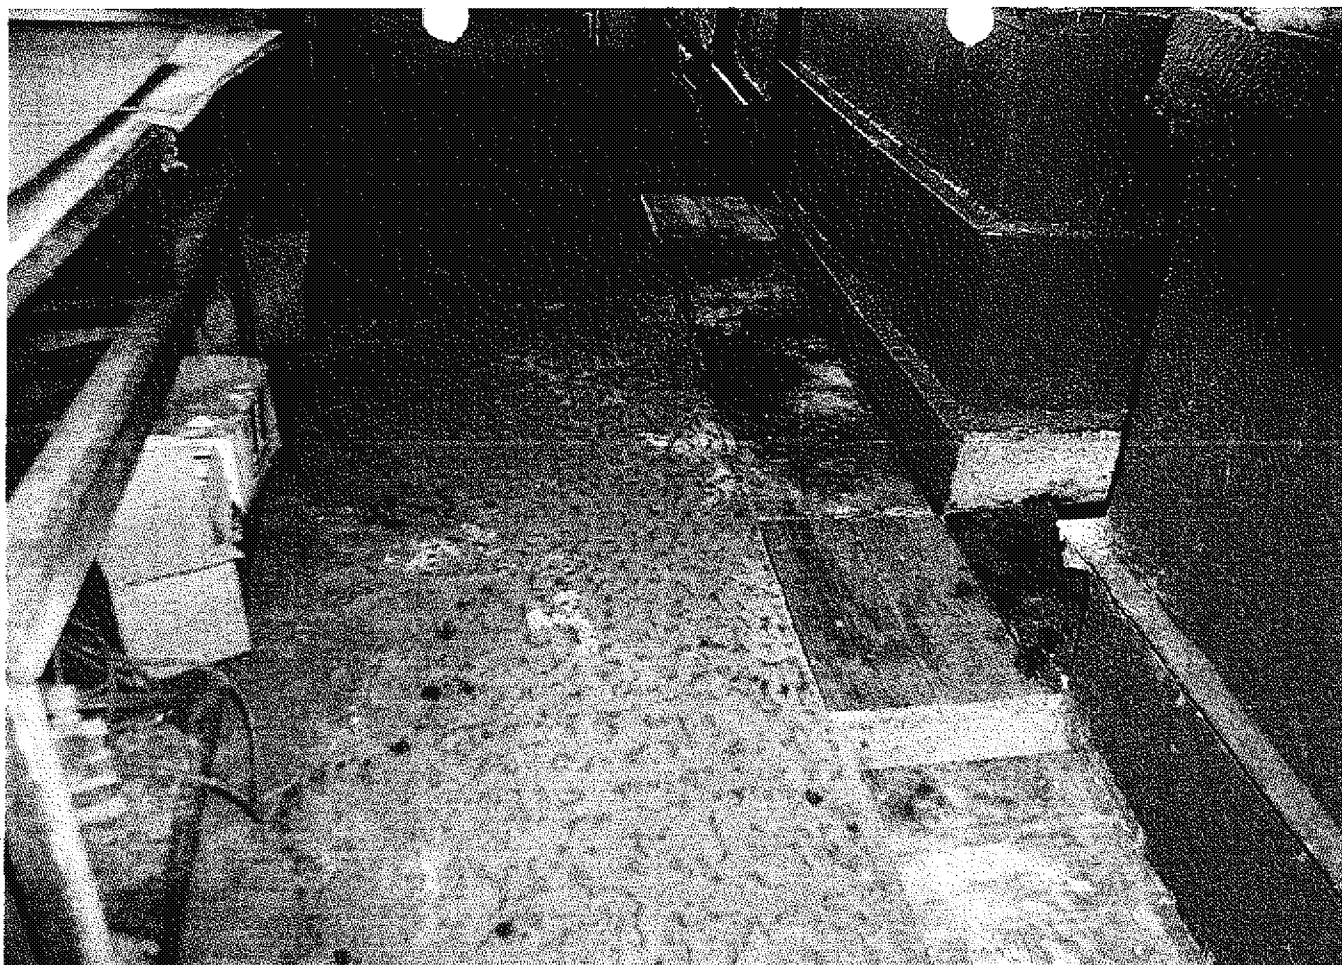
Floor between Zinc Line + Drying Rack – 13

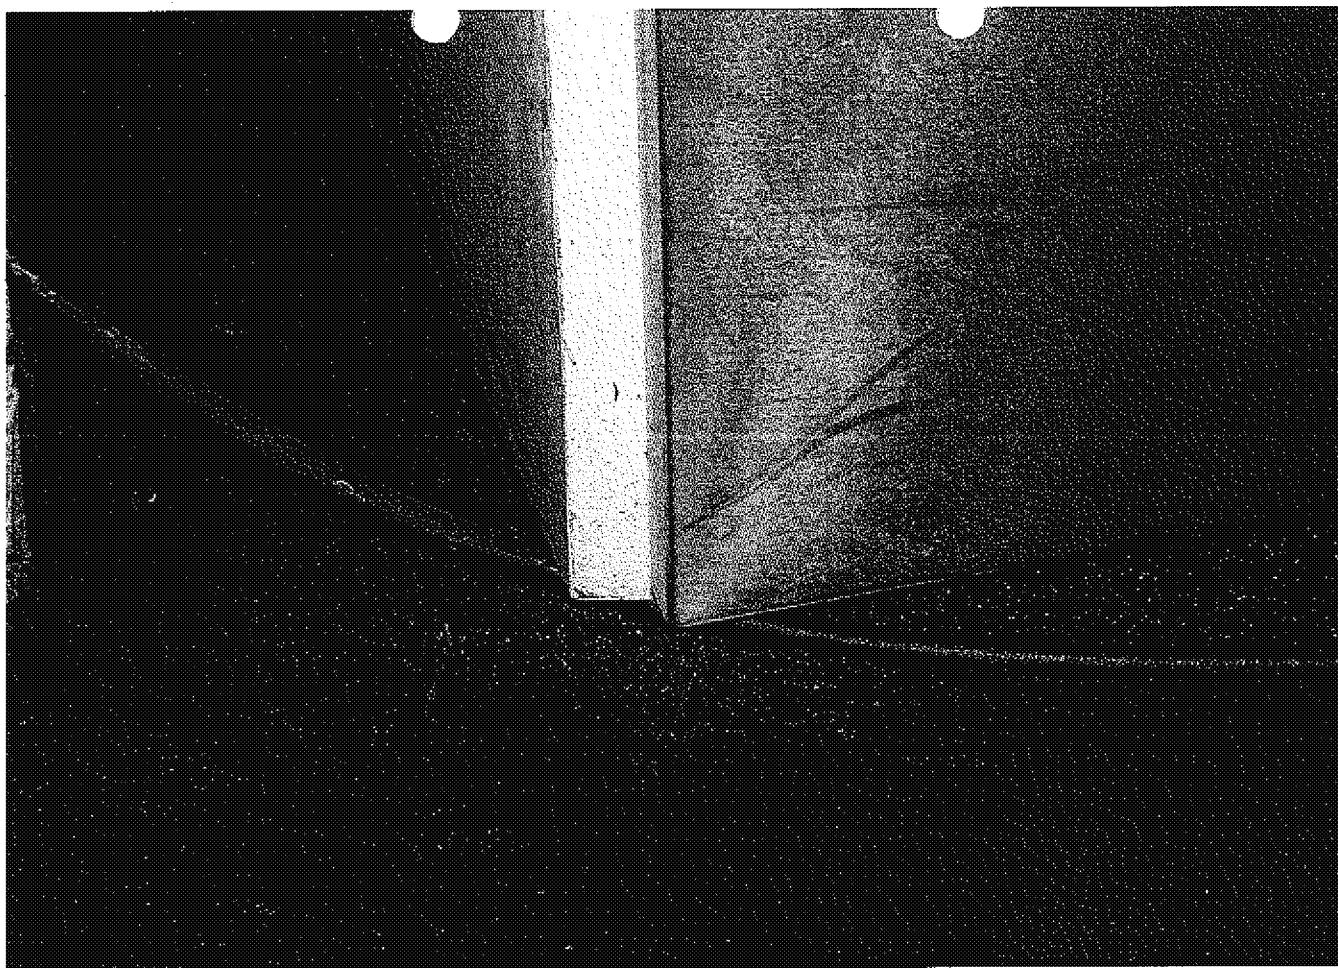
The next stop was in the southwest portion of the facility which is used for storage. In the storage area were 2 compressors and a dryer for powering tools and taking moisture out of the air line in the facility. In front of one of the compressors was a puddle of oily looking liquid (Photo #20). The next Stop was at the walk-in drying oven located at the back of the ZPL area (Photo #22 and #27). While walking to the Hazardous Wastewater Treatment System at the front of the ZPL room, there was a chemical stain on the floor (Photo #23).

Liquid on floor in front of compressor – 20

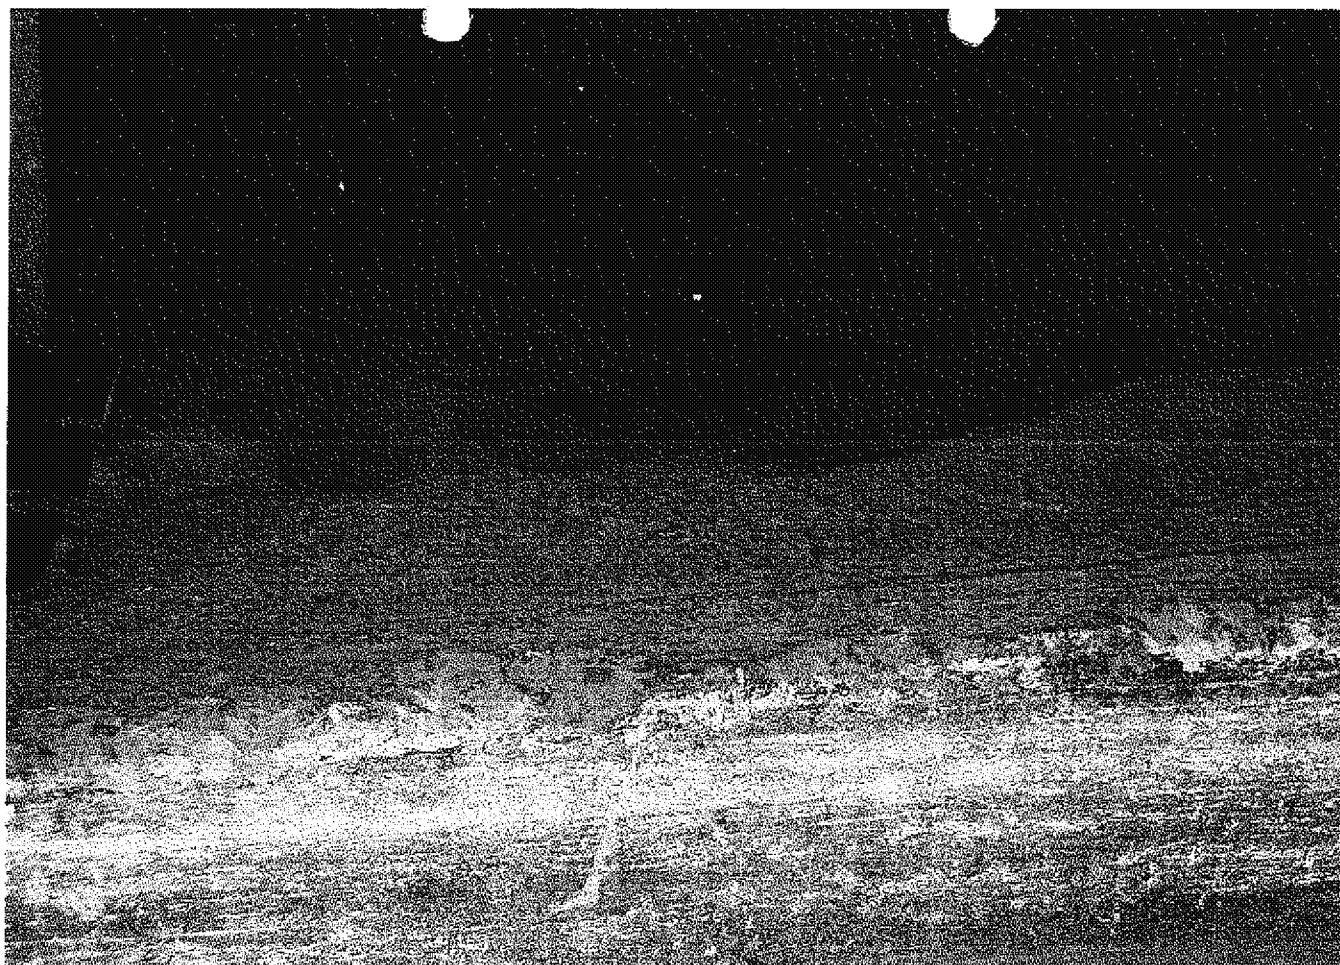
Floor Stain near Zinc Line - 23

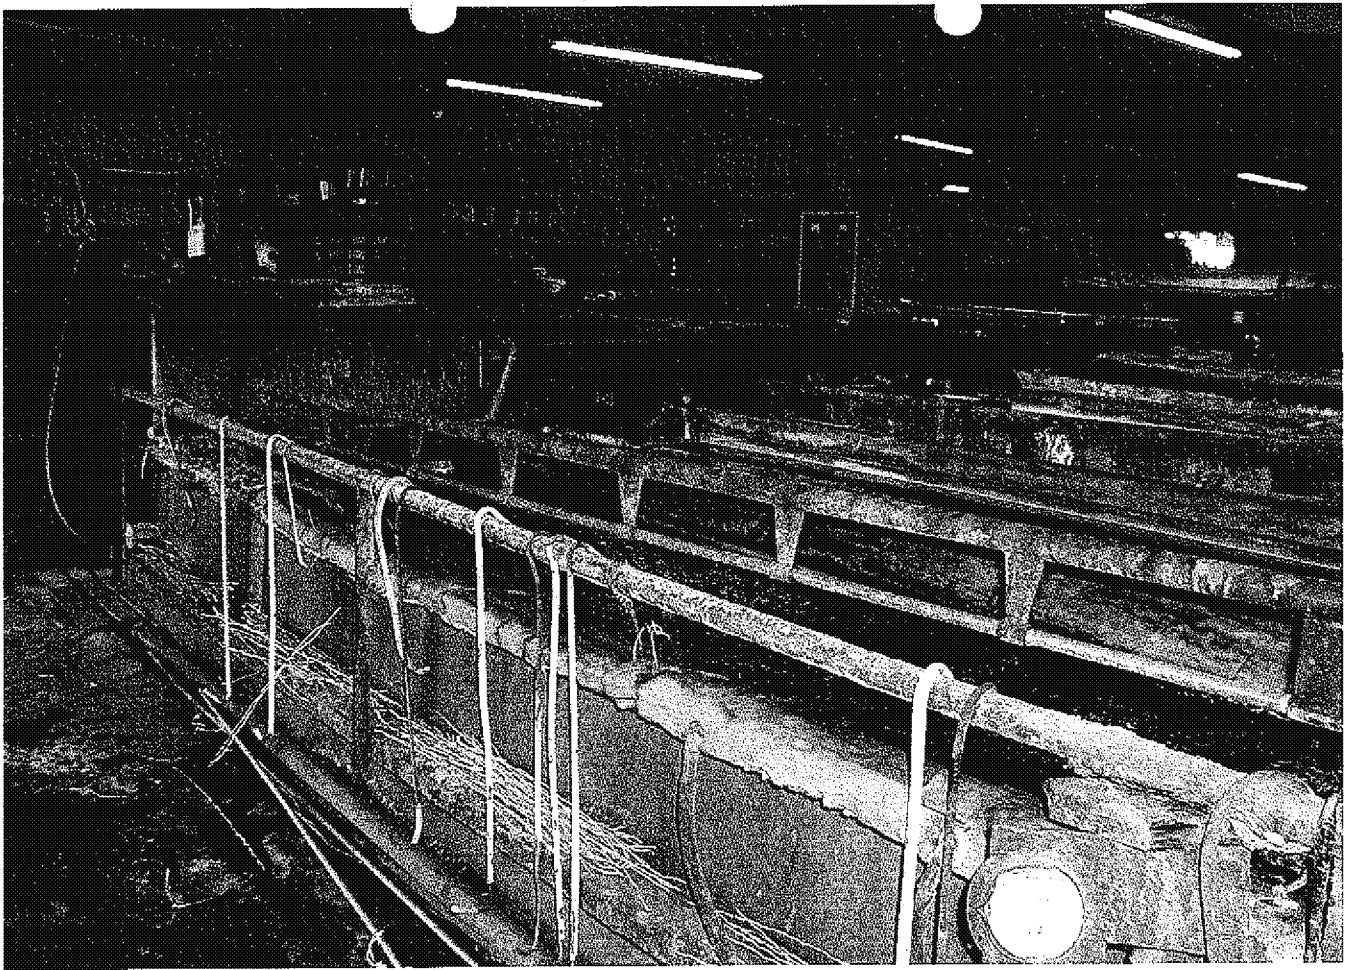
The next stop was at the Hazardous Wastewater Treatment System (system), located at the front of the ZPL room. The owner said the system was installed in 1993 as a State-of-the-Art-System (Photos #32 thru #38, #42 and #43). There were no leaks or spills observed. The next stop was at the Hazardous Waste Storage Area (Photos 39 + 40). No leaks or spills were observed. The next stop was next to the receiving area at the Aluminum Anodizing and Cadmium Plating Lines. Upon entering the second anodizing /plating room, the air in the room had a chemical odor. There were no visible fans, nor were there any doors opened to allow circulation of the vapors from the processing line tanks and the floor was wet. The owner was told about the observation and the floor should not be wet. The tanks of the Cadmium Plating Line were rusted with chemical residue on the tank sides. Some of the tanks had accumulated chemicals caked on the sides and around the rim (Photo #44). The floor around the tanks was wet. Portions of the tanks were dissolved by chemicals, leaving an uneven, jagged edge (Photo's

#45, #46, and #47). After we observed the Cadmium Plating Line and Aluminum Anodizing Line, we went to the owner's office where we discussed the inspection and when the owner could expect a copy of the finished inspection report.

Anodizing Line + Cadmium Line - 45

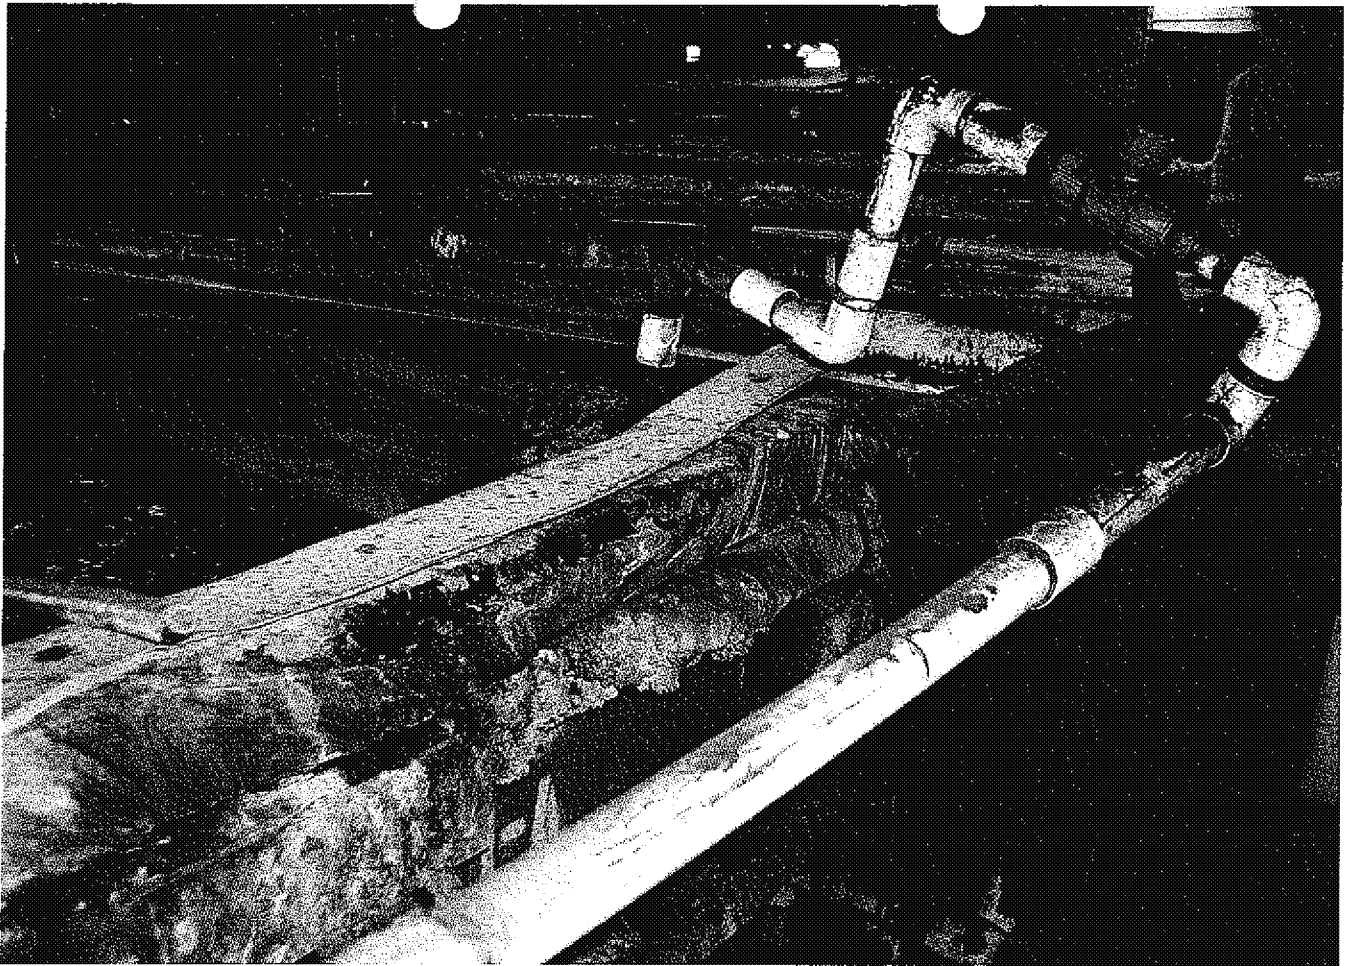
Anodizing Line – 46

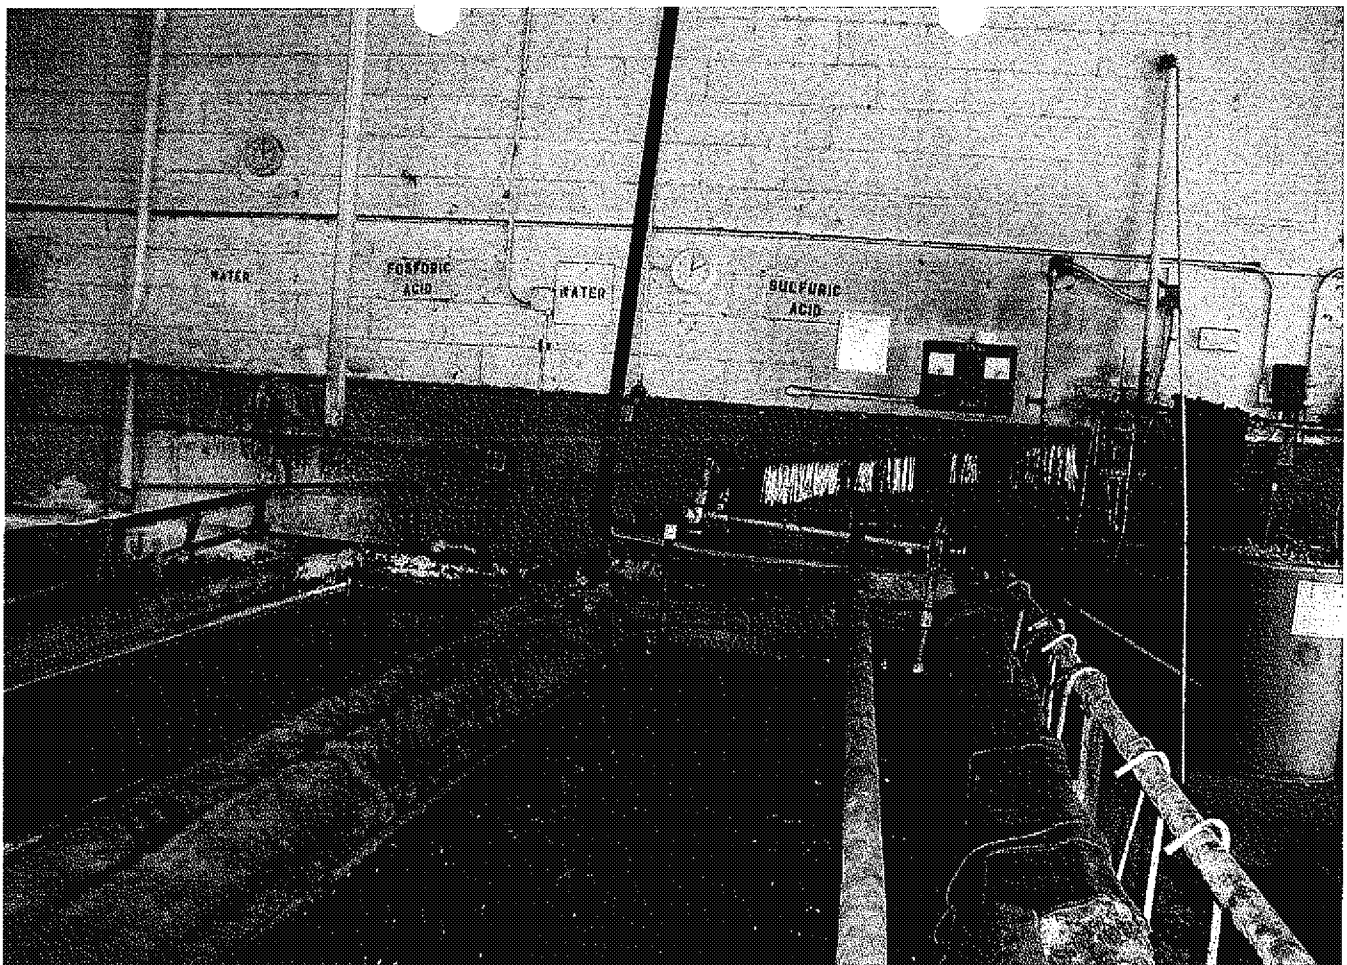
Anodizing Line - 47

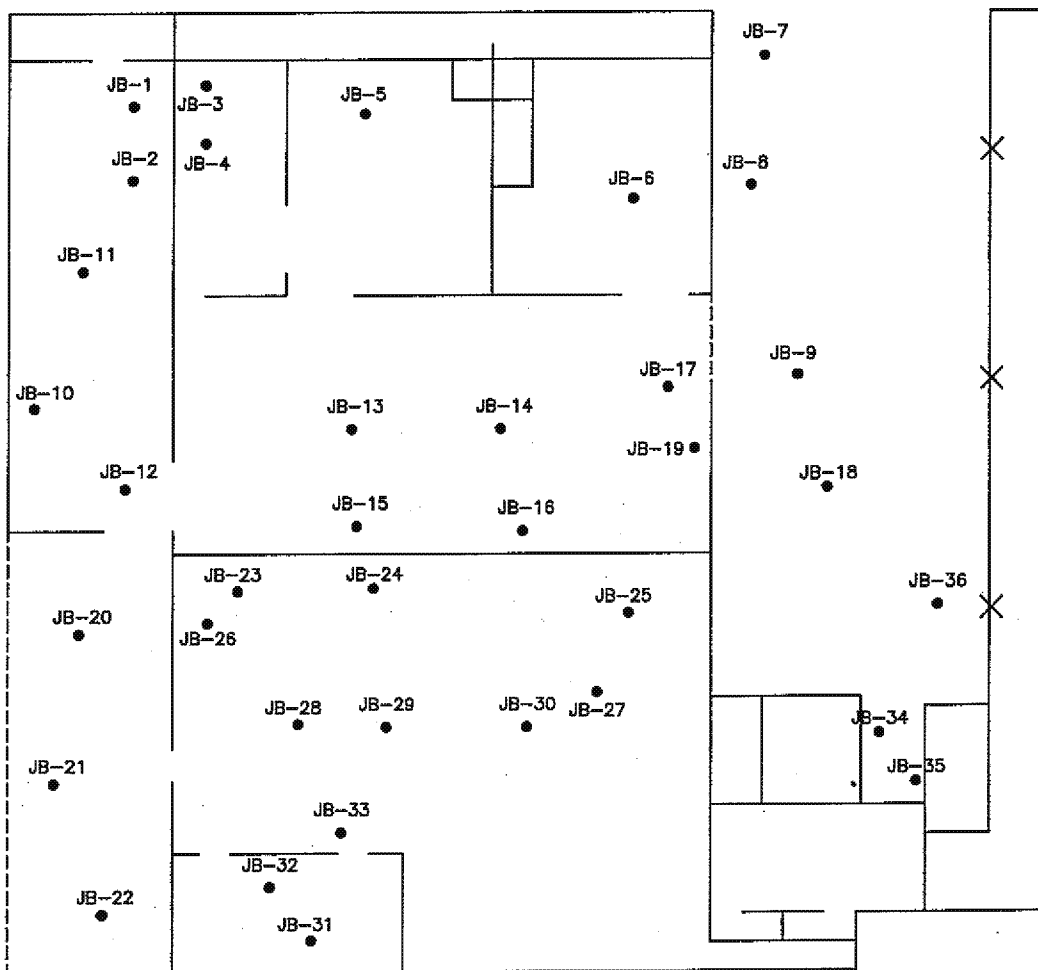
Figure 2

In 2001, a Limited Subsurface Soil and Groundwater Investigation (see figure 2 for sampling locations) was prepared for PCA Industries, LLC, master lessee of the site, by Jorgensen Environmental. A total of 36 borings were installed in the building and outside the building near the property line adjacent to the former PCA Metals site. The areas sampled were: The Anodizing and Cadmium Plating Lines, the Chemical Storage area, the former Degreasing Area, the former Filter Cake Accumulation Area, the Former Polishing Room, the Masking/Wrapping Room, the Northern ZPL, the Shipping and Receiving Area, the Southern ZPL, the Spray Booths and Waste Water Treatment Area.
